Manhole Inspection Summary

Manhole # S29CC1039MH

Insp Date: **12/12/06 9:33 AM**

Location Address: **3647 CHESTNUT AVE**

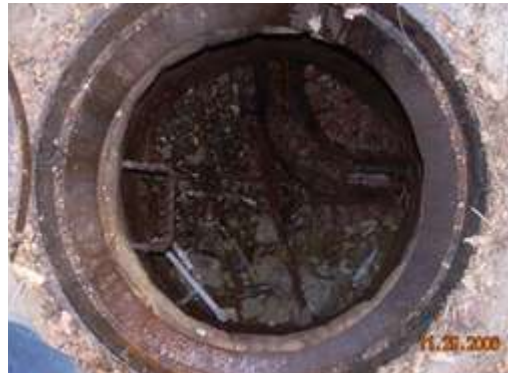
Top View

Frame leaks. Corroded steps. Evidence of surcharge - Bench debris. Channel debris.

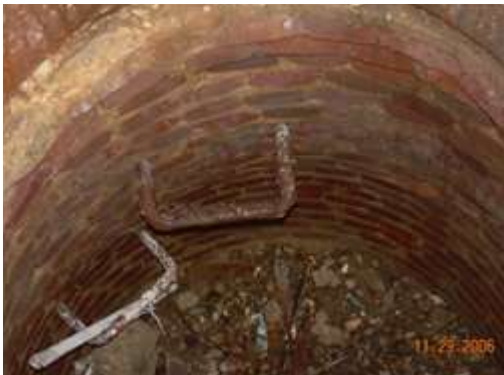
Defect

Adjustment and Corbel infiltration. Corroded steps. Channel debris.

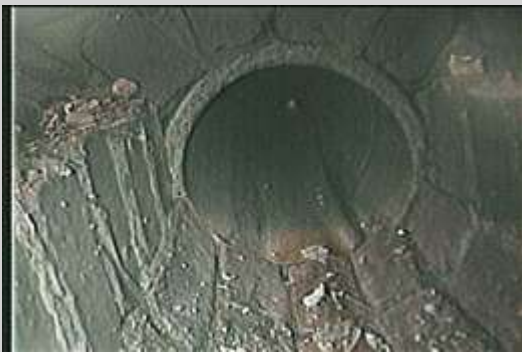
8 in. Circular Gravity Sewer Pipe Out @ 12 O'Clock

Infiltration: **Evidence** Pipe Seal Cond: **Cracked**

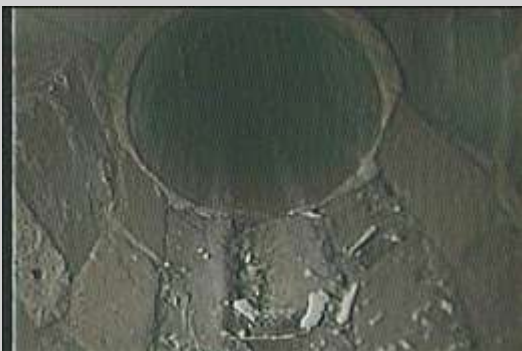
8 in. Circular Gravity Sewer Pipe In @ 3 O'Clock

Infiltration: **Evidence** Pipe Seal Cond: **Cracked**
